Why Restoration of the South Fork of the Trinity River?

Road Decommissioning

Before and After Photos of work 2004-2005

TCRCD Accomplishments 2004-2005

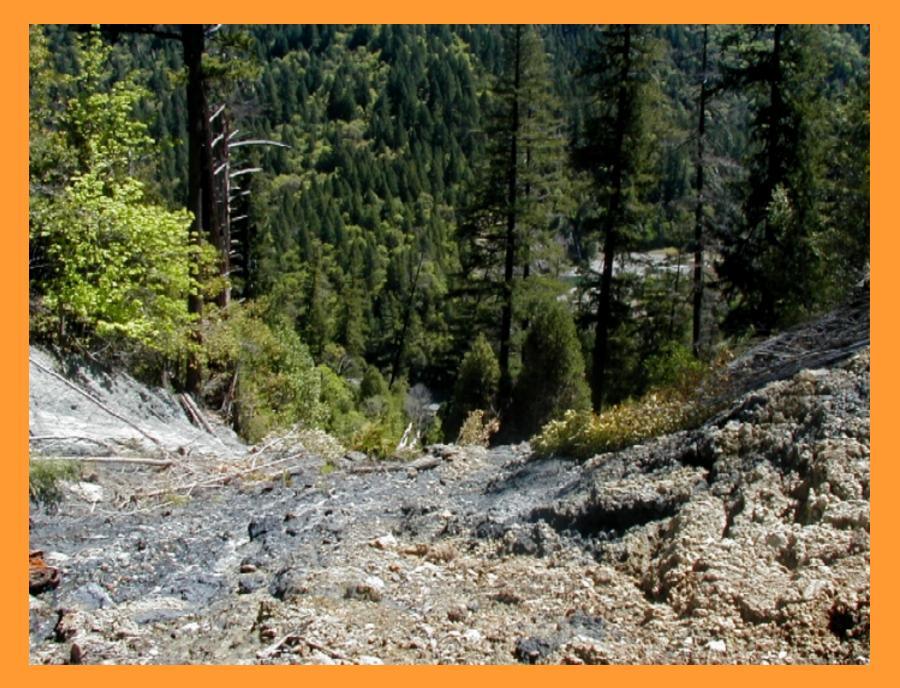
Landslides

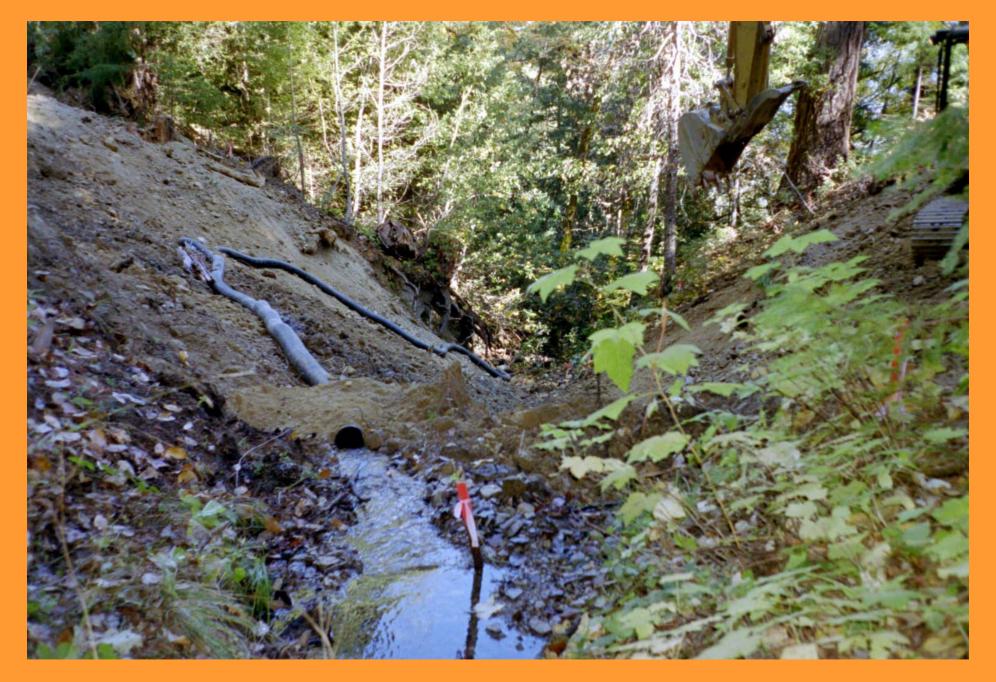
Active Streams

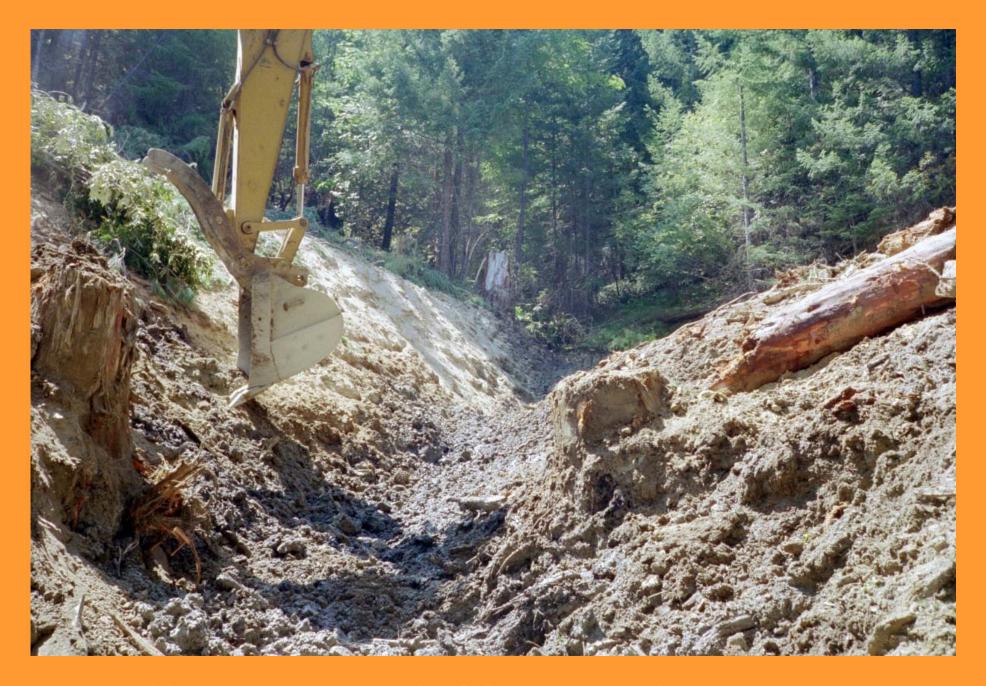
Indicators of Channel Bottom

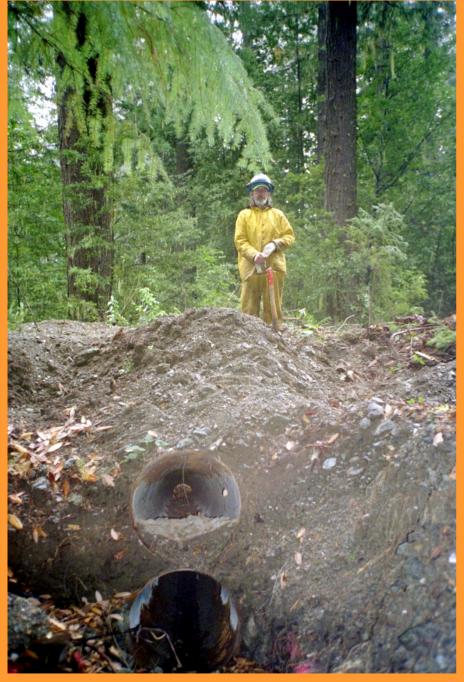
Before Excavation

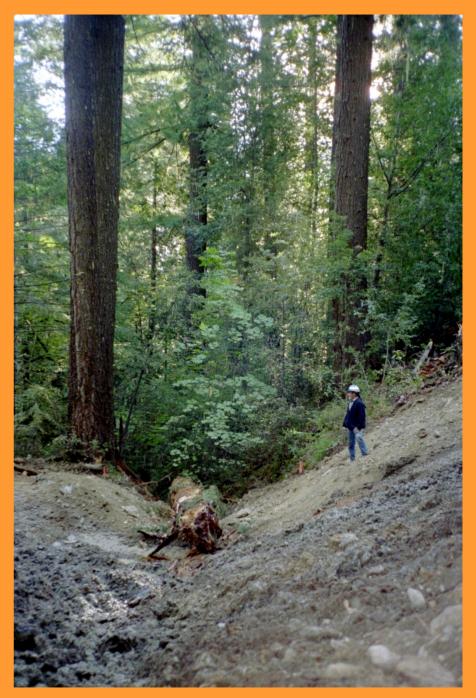
After

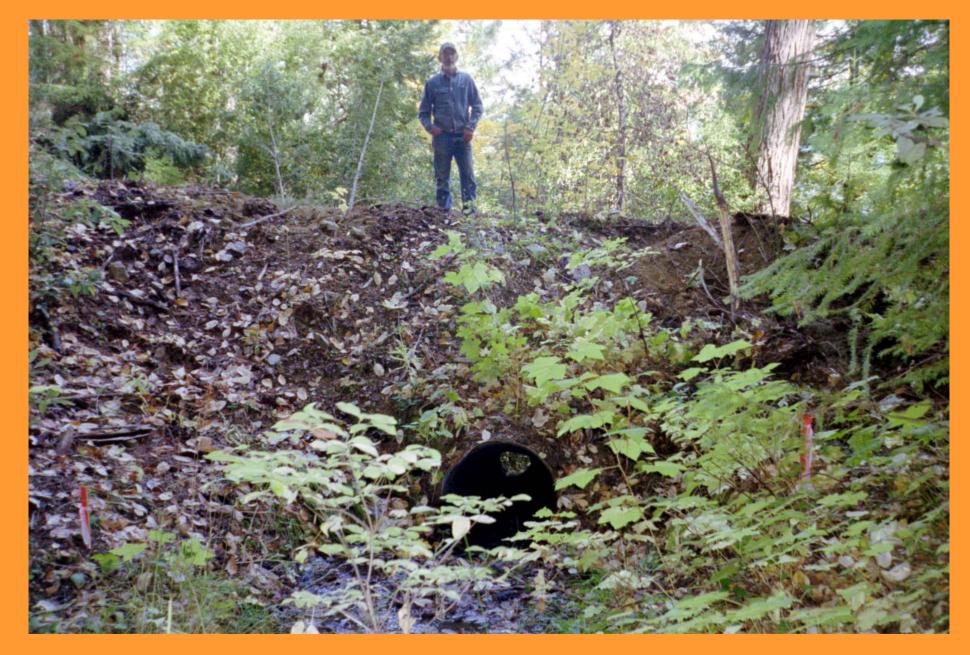
Before

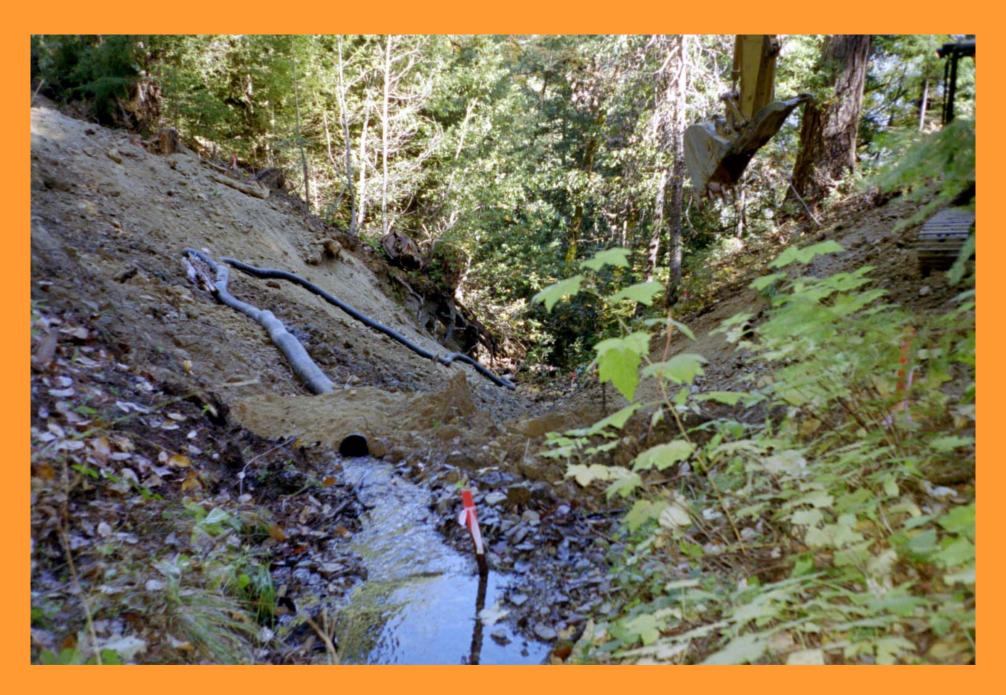
De-watering pipe installed

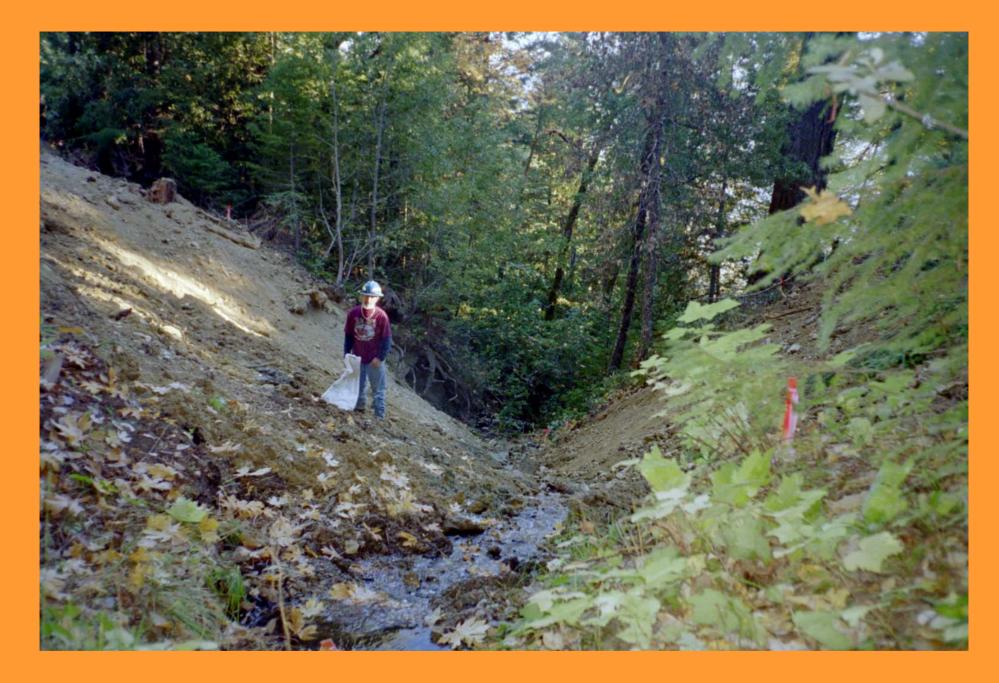
After Excavation

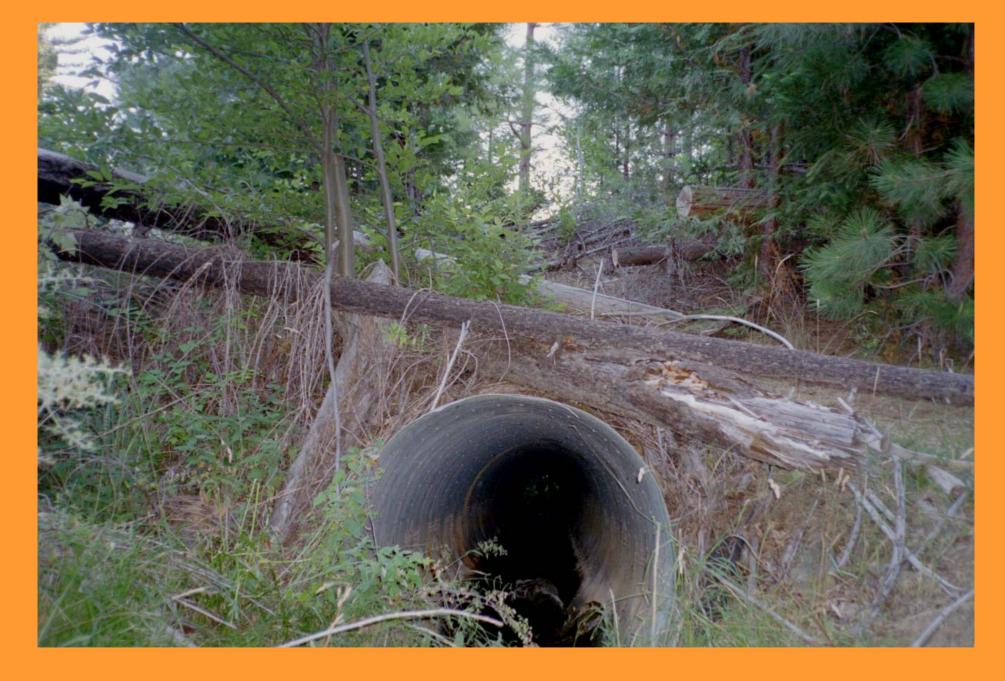
Before Excavation

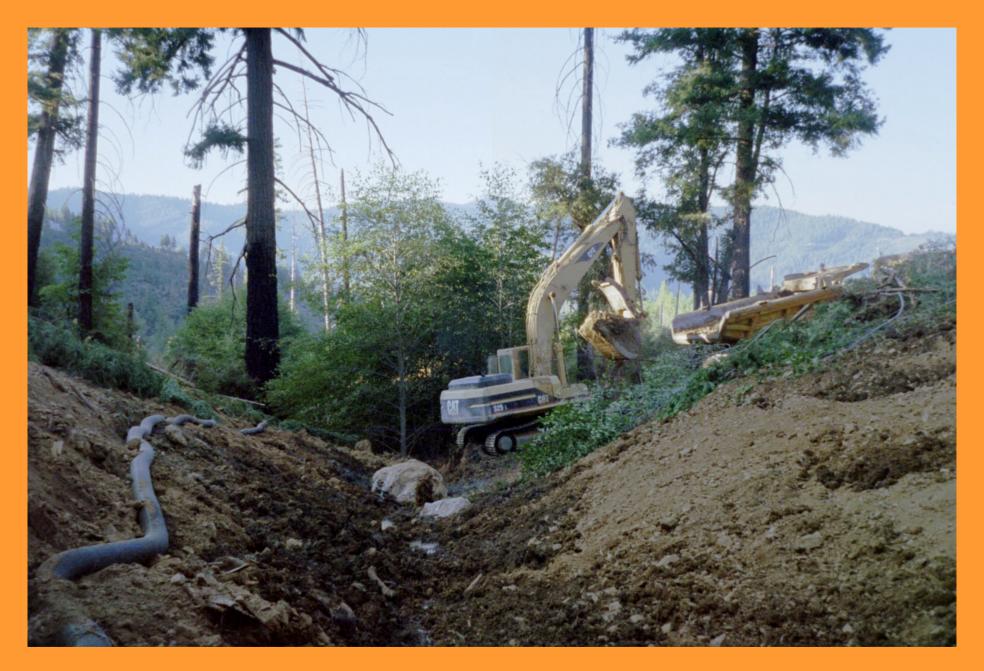
Excavation near completion

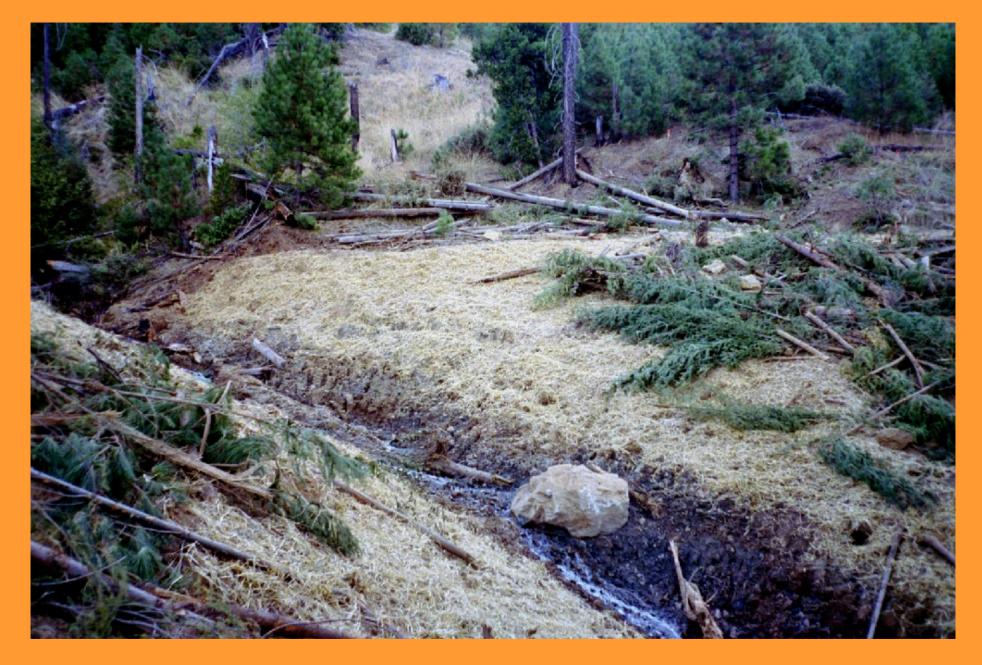
After Excavation

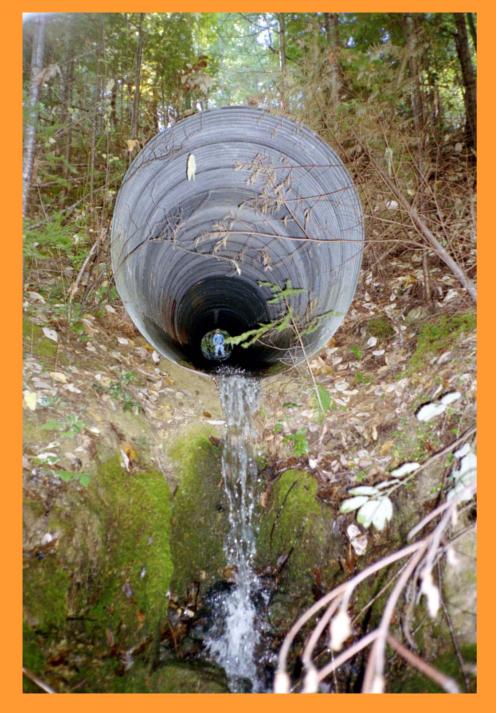
Before Excavation

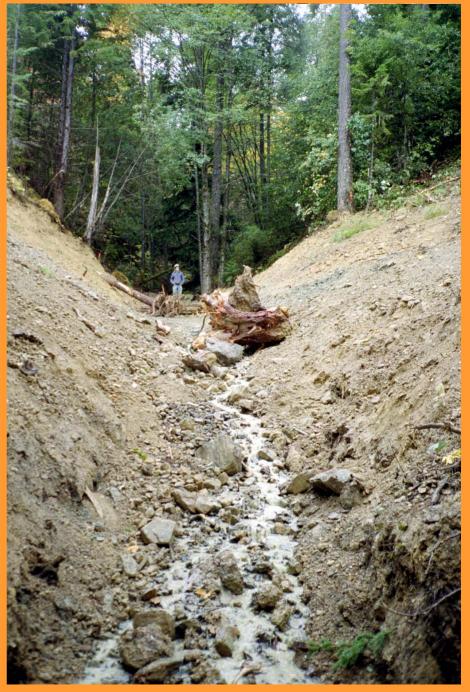
After

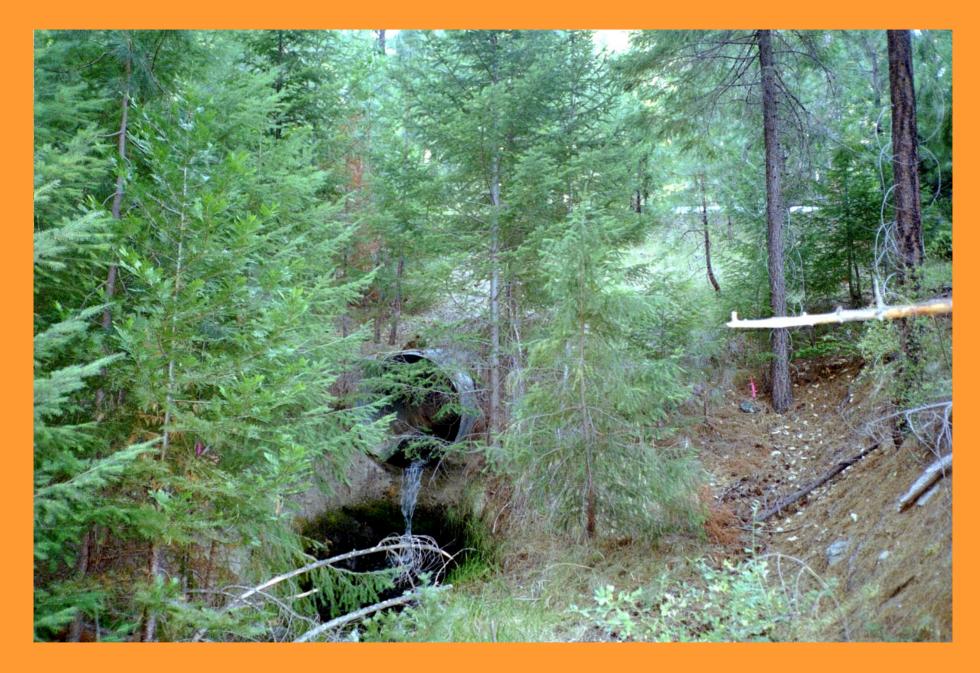
Before Excavation

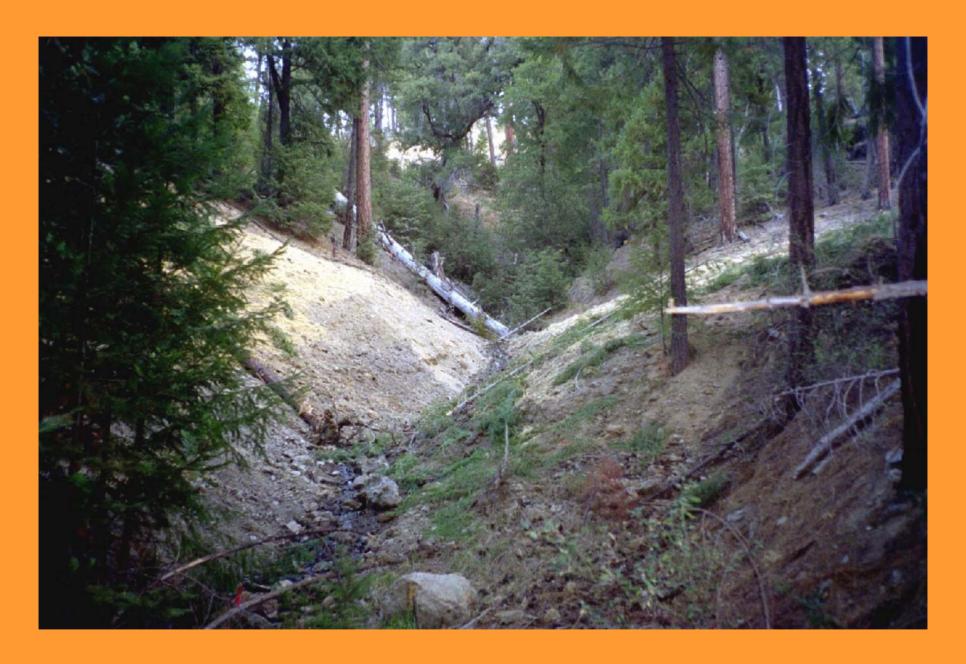
After Excavation

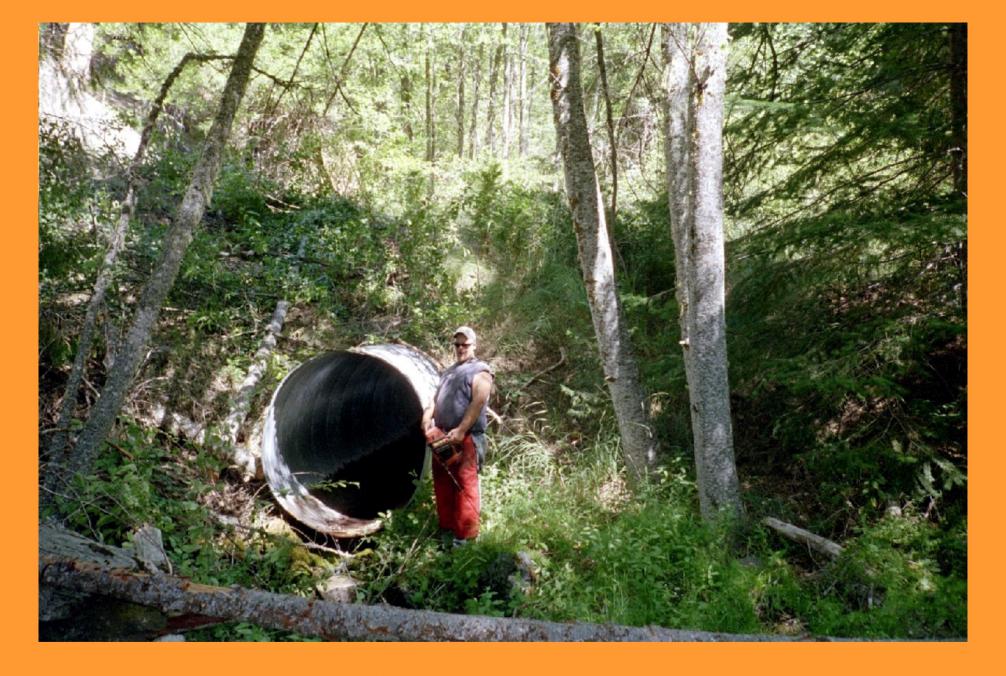
Before Excavation

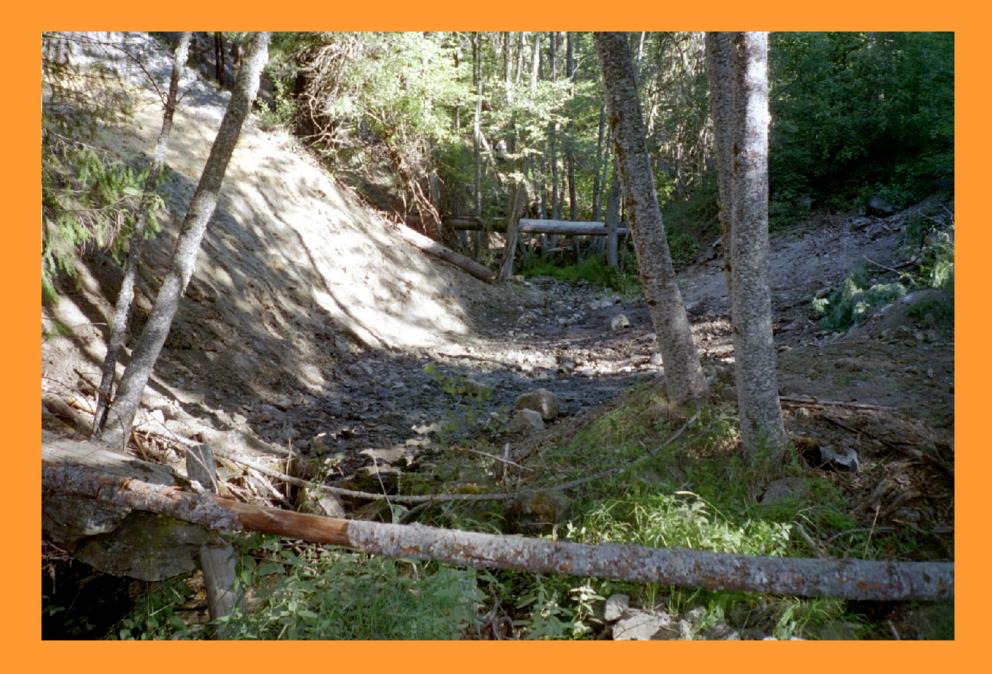
After Excavation

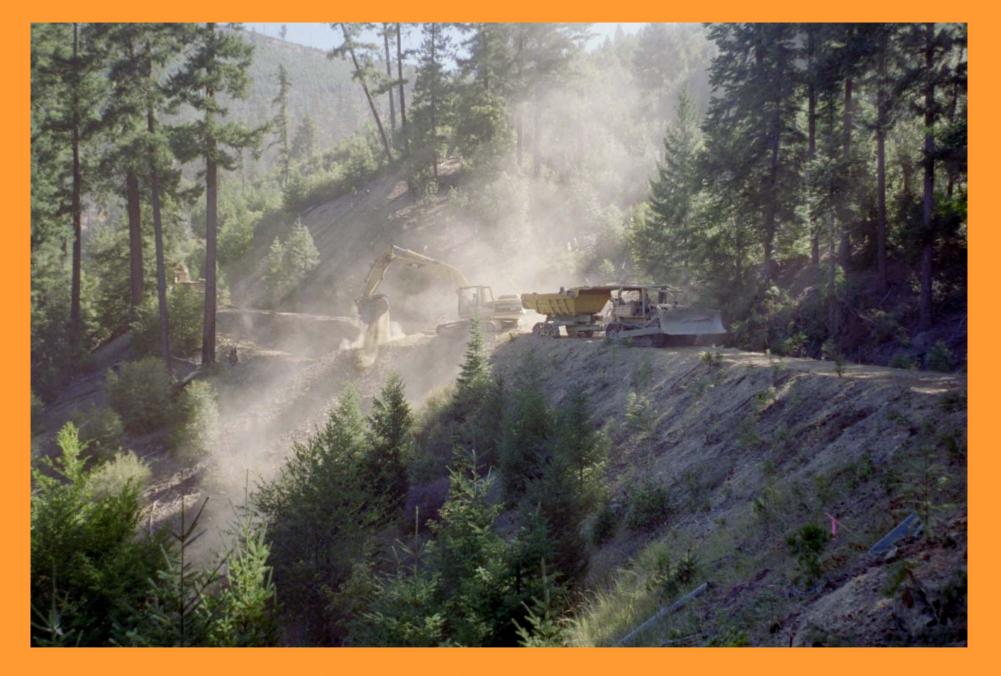
Start of Excavation

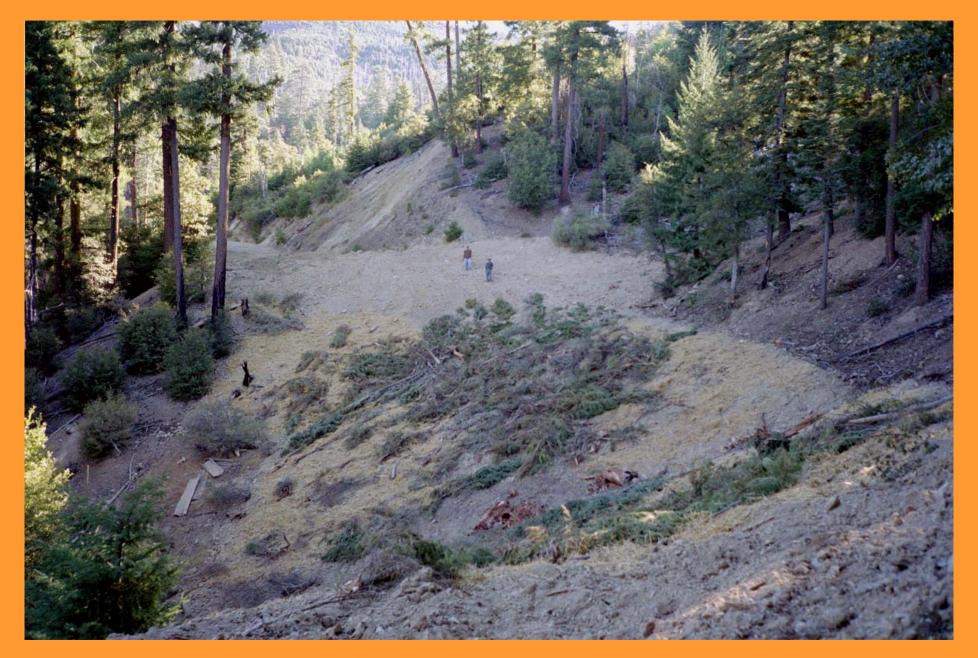
After Excavation

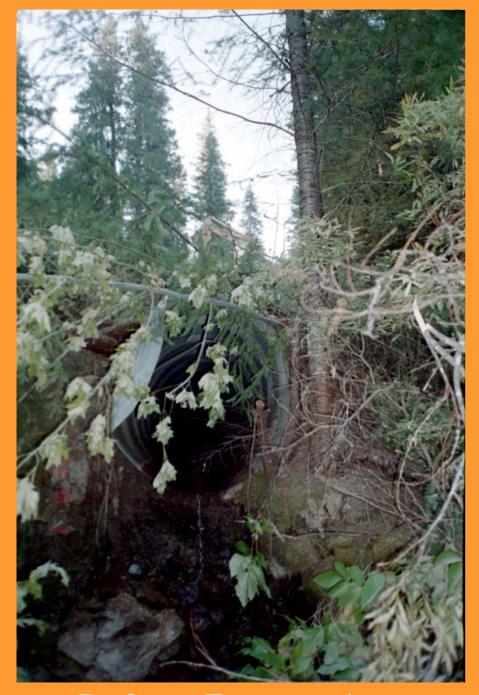
Before Excavation

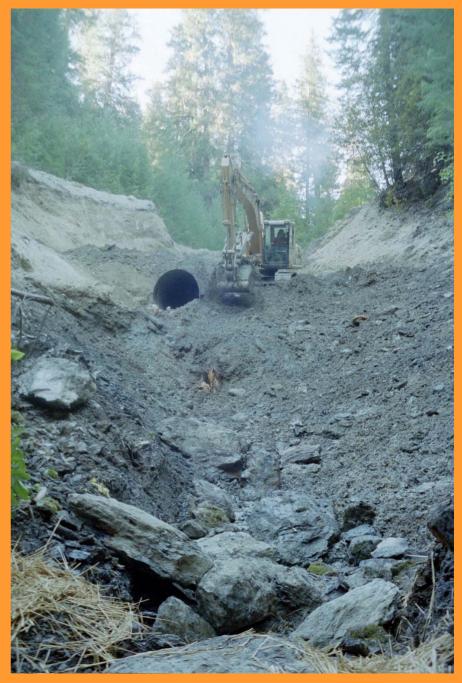
During Excavation

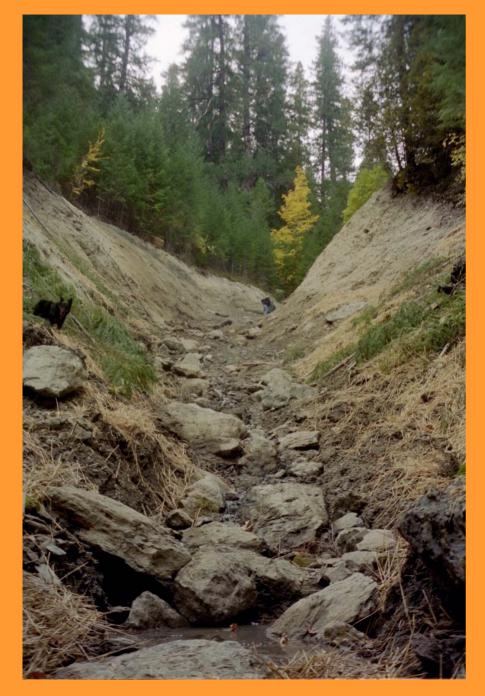
After Excavation

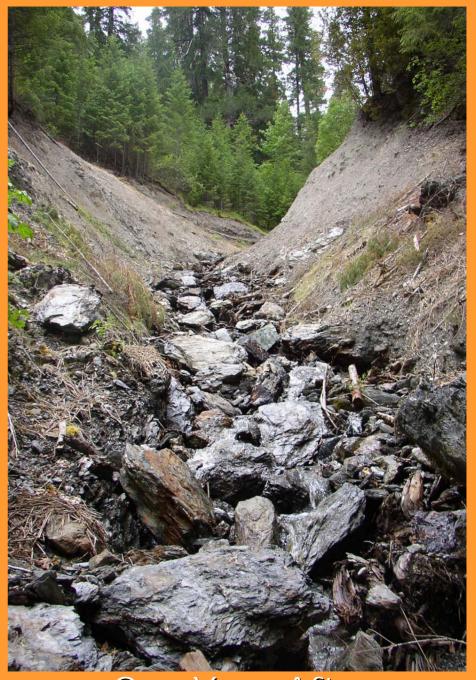
One Year After Excavation

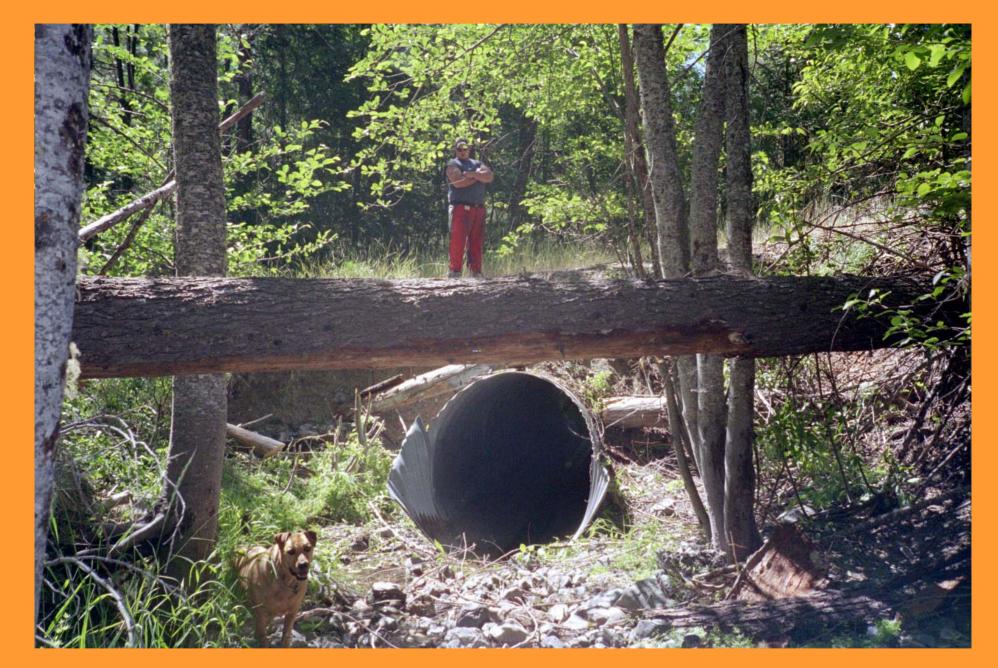
Before Excavation

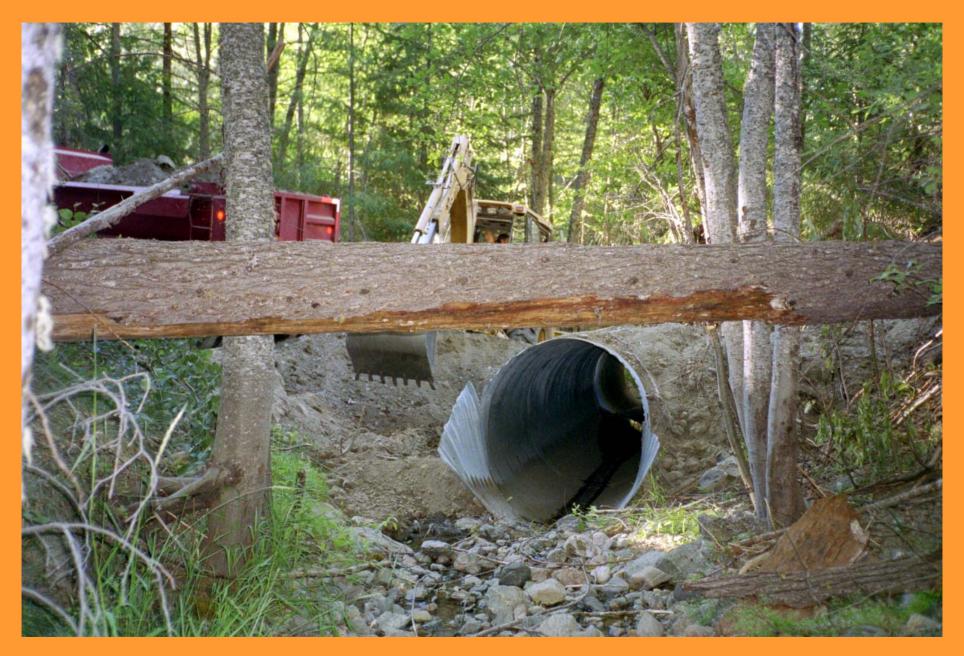
During Excavation

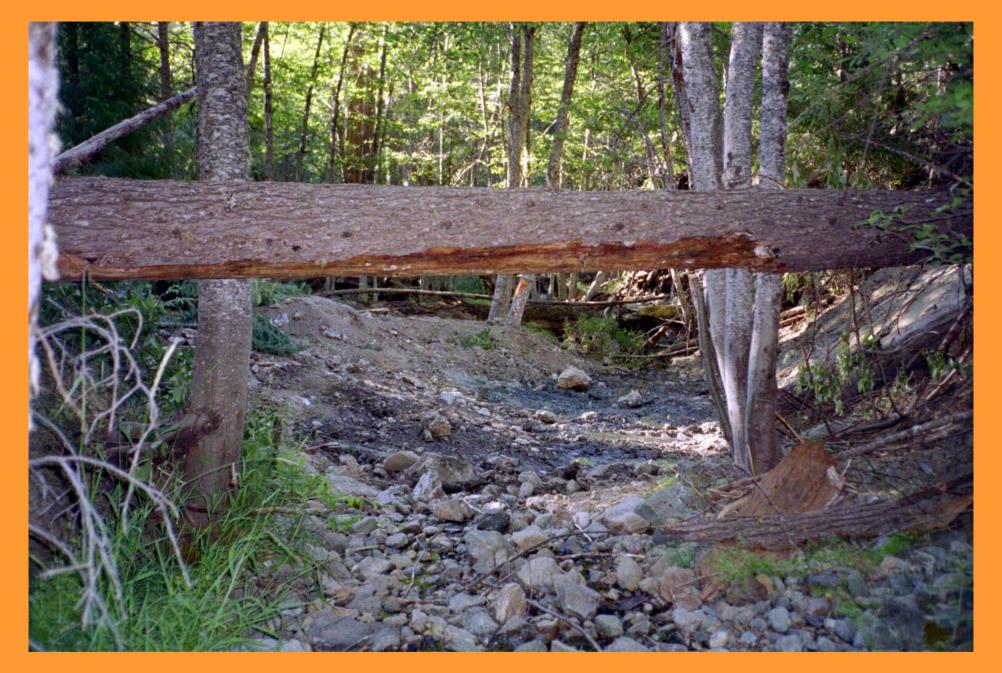
After Excavation

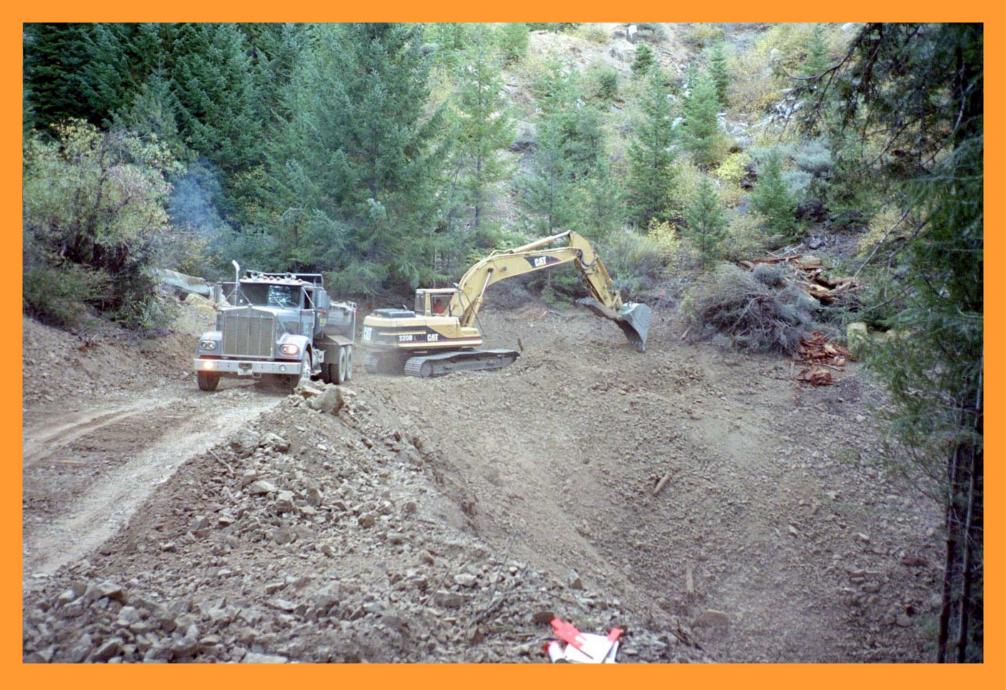
During Excavation

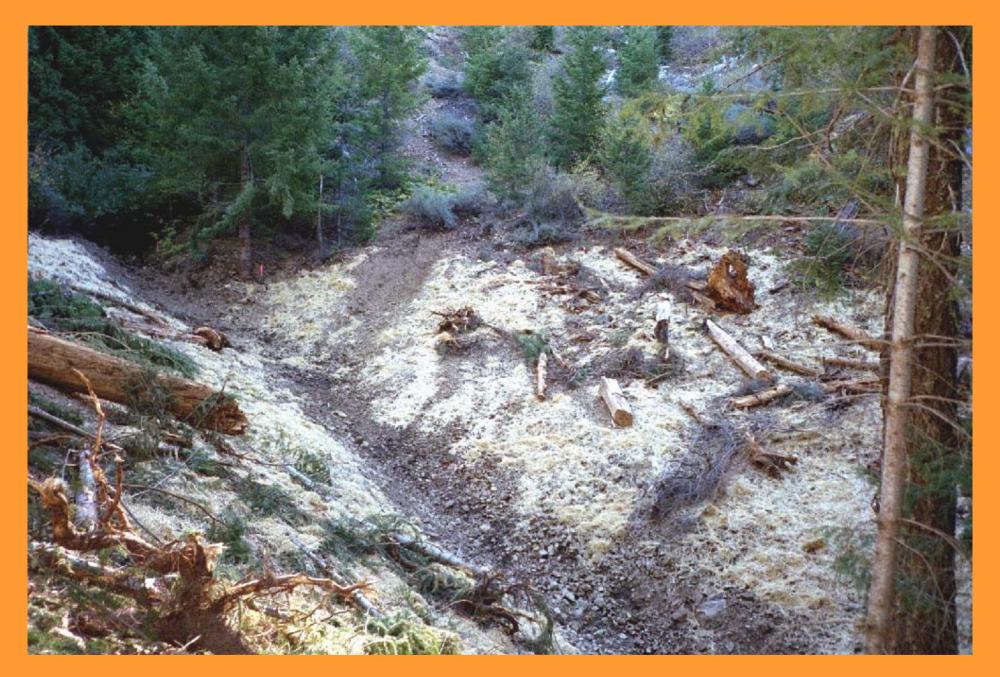
After Excavation

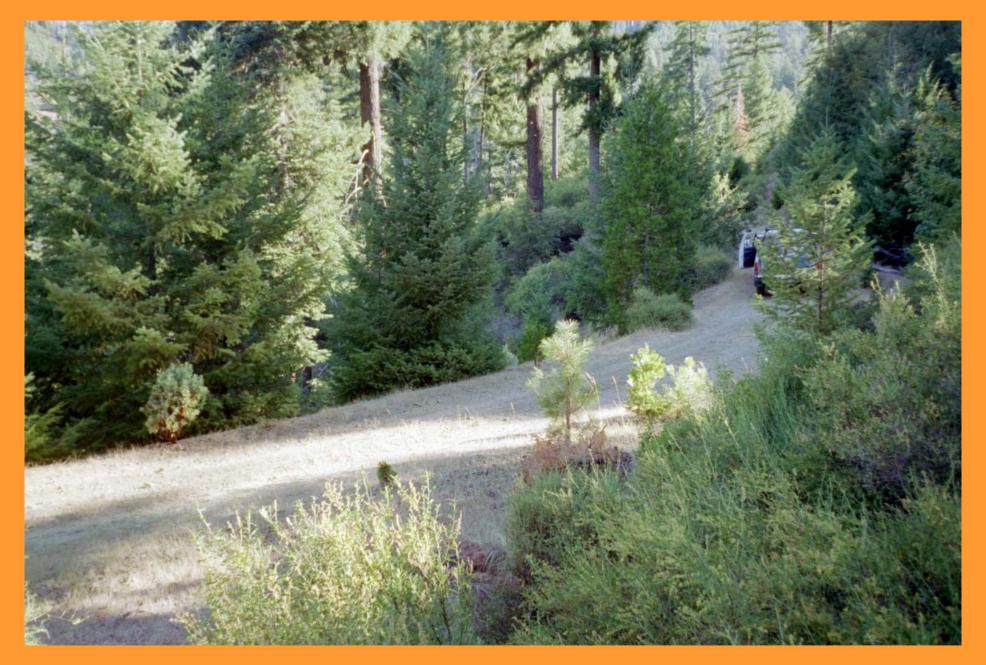
Before Excavation

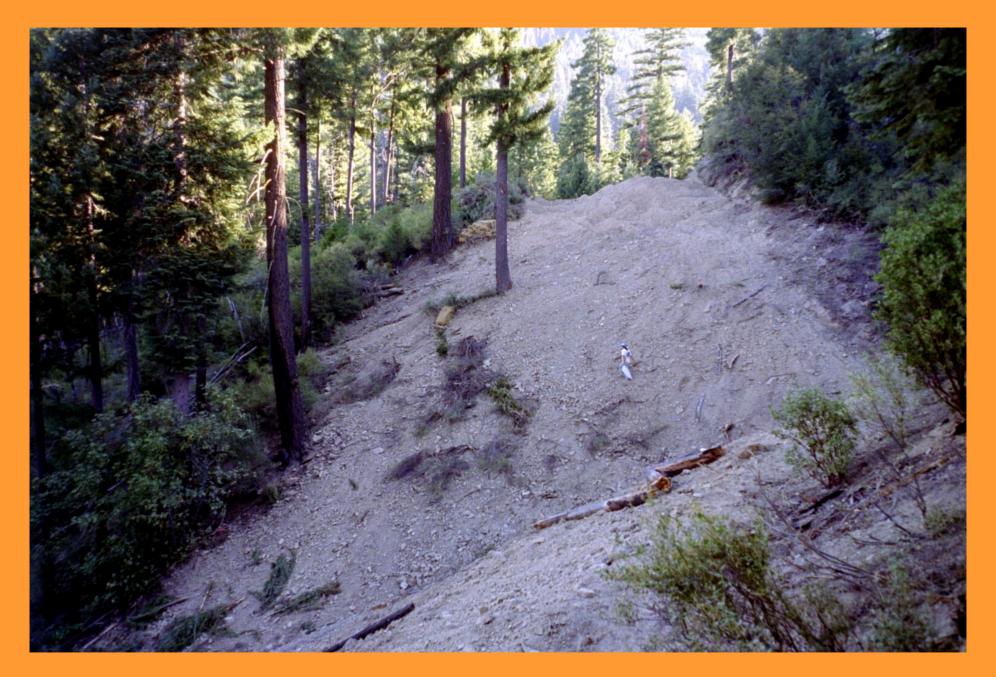
After Excavation

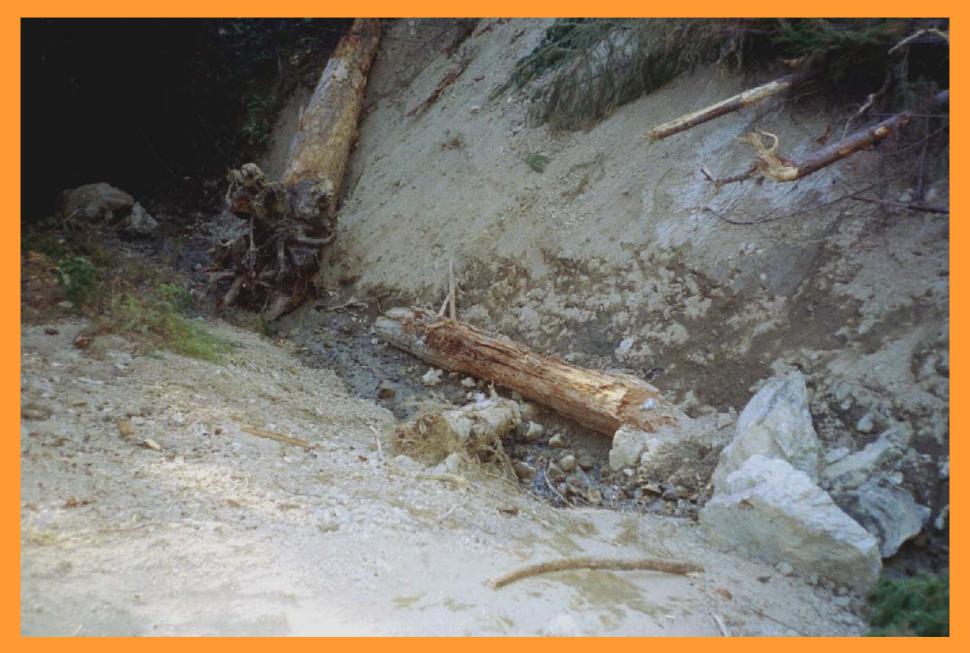
Adding Channel Complexity
